Test Report

No.: CANEC24006999011

Sample Name: XLPO wire and cable

Model No.: UL3173 20AWG Green

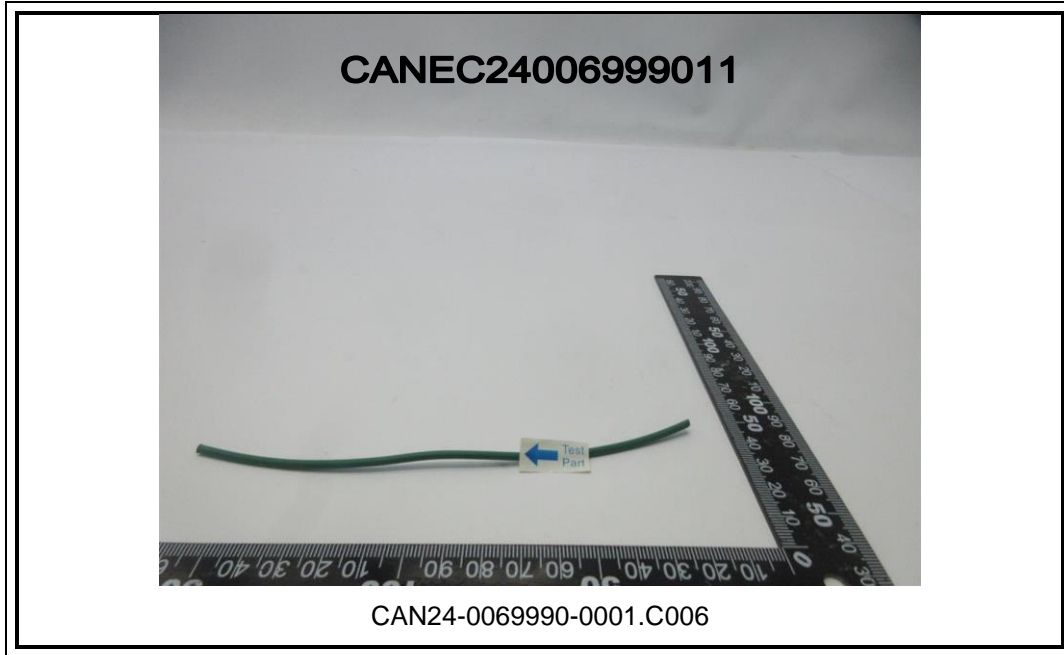
Sample Photo:

SN ID	Sample No.	SGS Sample ID	Description
SN1	A6	CAN24-0069990-0001.C006	Green plastic jacket with black printing
